Application Field: Concrete Repair

HYDRO SCHEME TASMANIA

Date: November 2003	Location: Liawenee Canal, TAS
Specifier: HEC	Contractor: Mersey Plant Hire
Sika Representative: Andrew Wilkie	Reference:

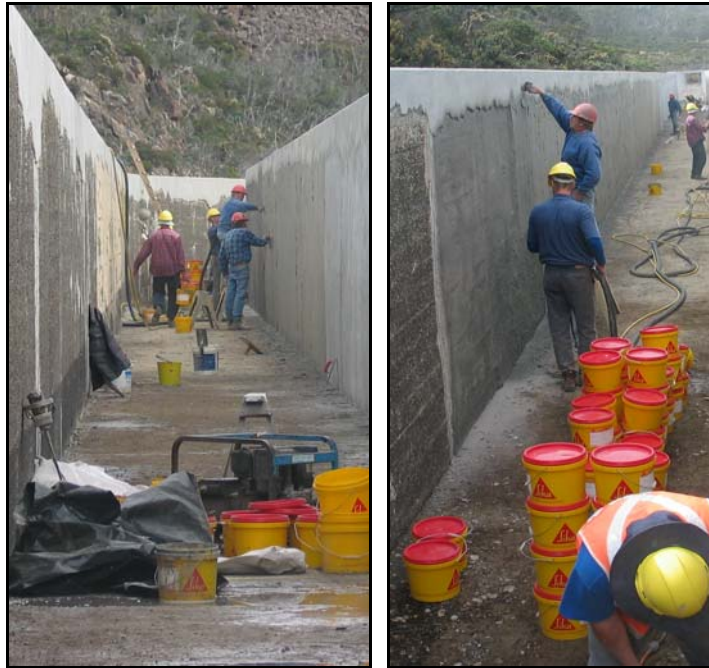
Requirement: Over the years freeze and thaw cycle has caused extensive damage to the tops of the flume walls and large sections had eroded from the interior of the flume. Urgent repair was required.

Solution: Due to the extensive break out of material, an overlay of Sika MonoTop-615HB was specified, bonded down using SikaTop-110 EpoCem priming agent. The topping was then coated with Sikagard-680S to provide a curing membrane and a protective coating.
