Application Field: Concrete Repair and Waterproofing

Market Field: Water Industry

## BEENYUP WASTE WATER TREATMENT PLANT

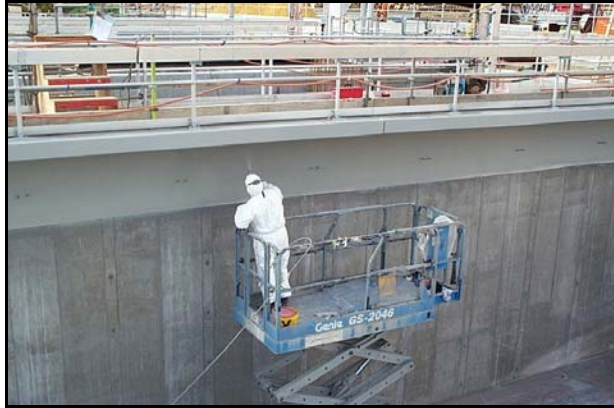
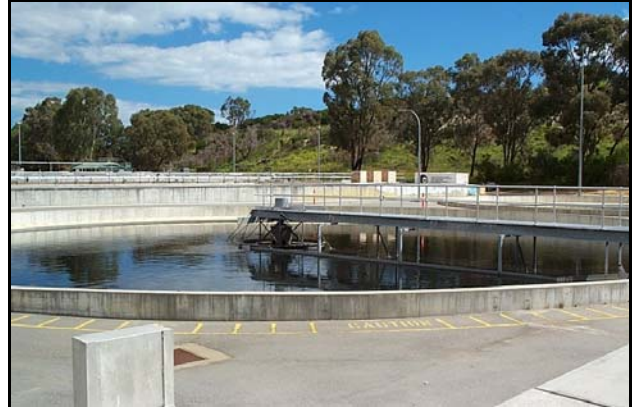
**Requirement:** The sewerage treatment plant required urgent restorations due to decay to the concrete water tanks.

**Solution:** Sikagard-62 provided the protective coating to pits, tanks and channels whilst Sika MonoTops provided corrosion protection for reinforcement. Sikagard-720 EpoCem then provided a temporary moisture barrier for subsequent epoxy coatings. Sikadur-Combiflex was finally used as a sealing system. Total area covered was 2000m.
