Application Field: Concrete Repair

Market Field: Reinforced Concrete Structures

BOTANY SWOOS SECTION

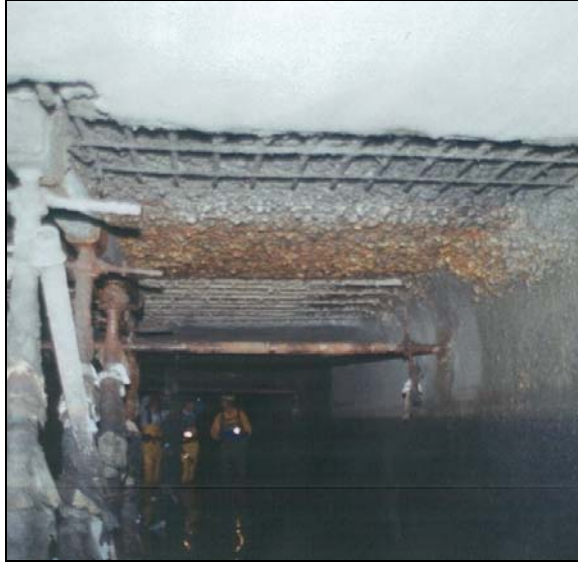
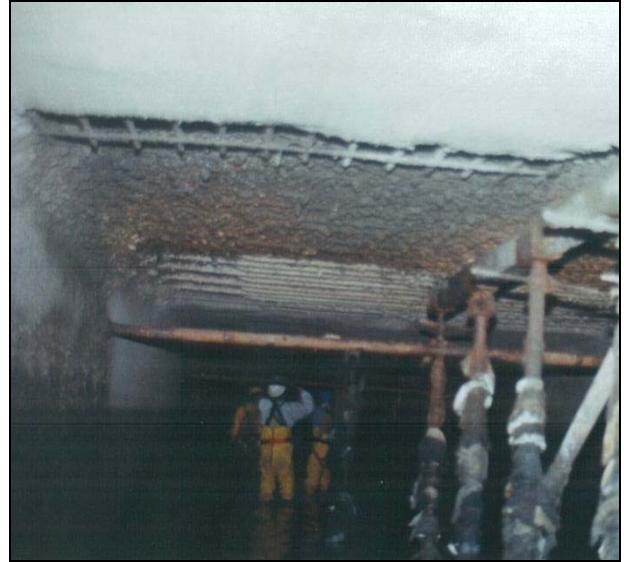
Requirement: A large section of the sewer-line under a main road in Botany was badly decayed and there were risks of collapsing. Urgent repairs were required.

Solution: SikaGunitite GP was used to reinstate 100mm thick of concrete on the roofs and walls (over 300m²). Sikagard-720 EpoCem was used as moisture barrier, followed by a coat of Sikagard-62 protective coating.
