Application Field: Concrete Repair and Sealing & Coatings

Eastern Creek Waste Management Centre

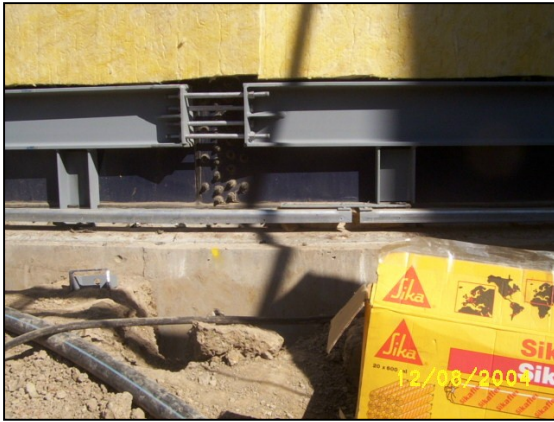
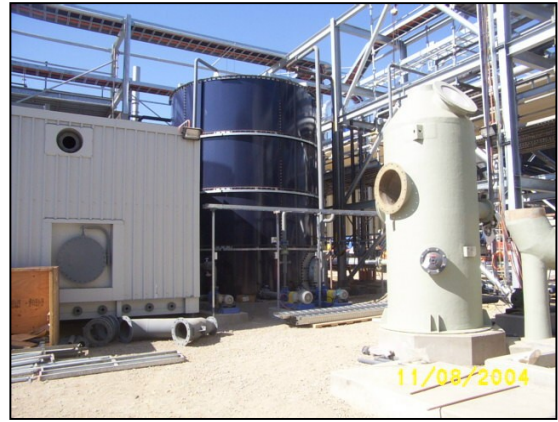
Requirement: The Waste Management Centre established several new storage tanks which are made of glass-metal trifusion and required a durable and strong sealing system for the joints and floors.

Solution: A unique joint design was designed that included Sikaflex-PRO in two stages. Stage one involved the Sikaflex-PRO in a 20 x 10 mm joint. Stage two involved putting a de-bonding tape on the applied Sikaflex-PRO and creating a 20 mm chamfer on top of it and bonded to the metal-glass surface.

Sikadur-Combiflex membrane was used to cover the walls and floor joints around the internal perimeter of the tank. The tank floor was repaired using Sikadur-31 and Sikadur-52 injection system. Lastly, it was waterproofed with a composite system based on Sika Tite-BE and Sika Tite-RC
