Application Field: Concrete Repair and Protection

Market Field: Reinforced Concrete Structures

## FRANSISCAN FRIARY (WAVERLY CHURCH)

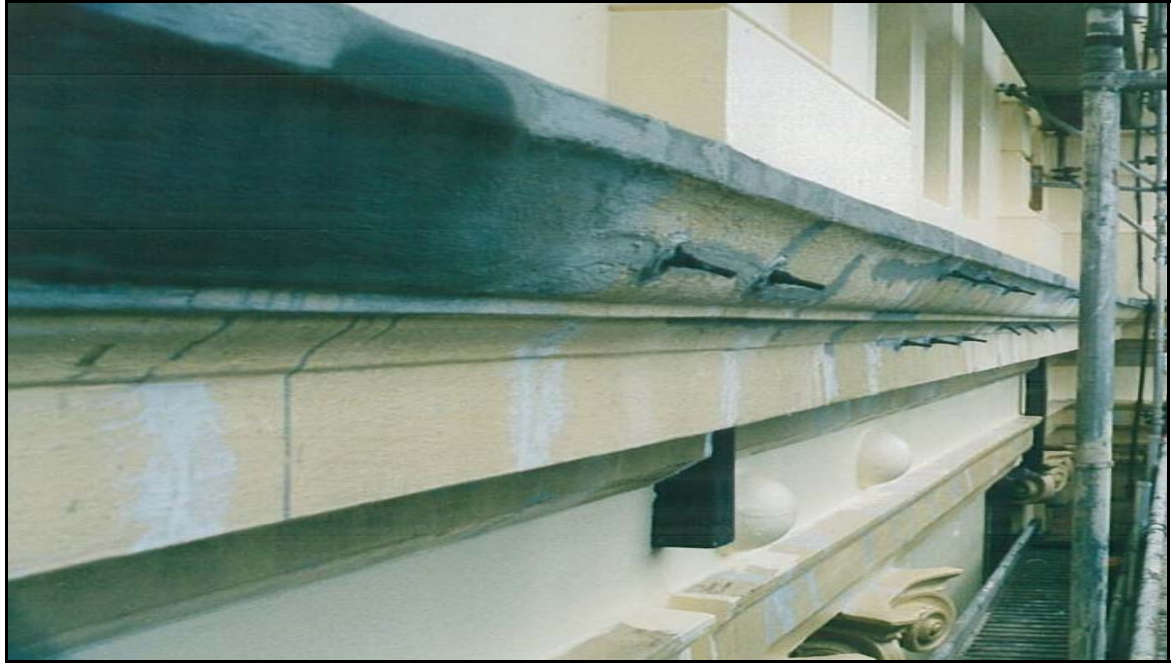
**Requirement:** The external corbel (as shown) had severe cracking and spalling with roof parapit walls splitting. Urgent repair was required for public safety and to restore the structure.

**Solution:** Sika MonoTop-615HB and Sikadur-52 was used to repair cracks and internal void filling. Other cracks and splits were fixed with Sika Anchorfix-1.
