Application Field: Concrete Repair

GARDEN ISLAND DRY DOCK REPAIR

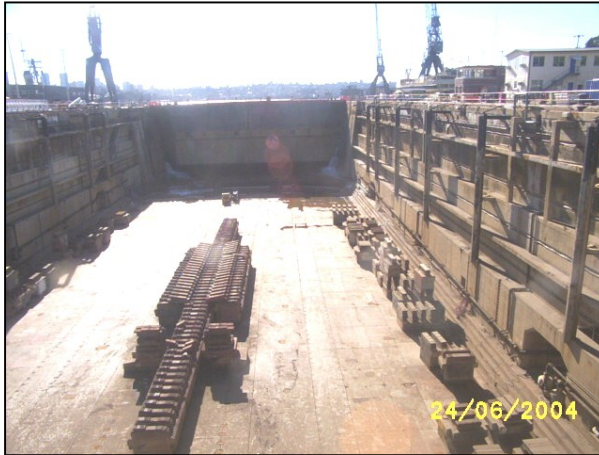
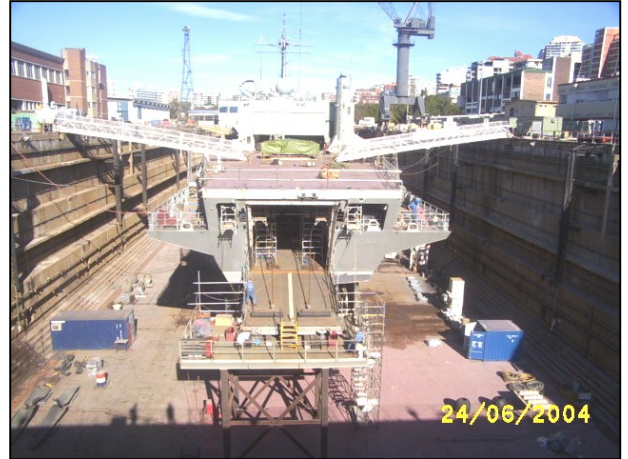
Requirement: The Garden Island Dry dock is the largest dry dock for ship repair in the southern hemisphere. The concrete structure of this dry dock required urgent repair due to corrosion.

Solution: A micro concreting system using the high performance SikaGrout 212HP, mixed with sand and blue metal aggregate, was designed to rebuild corbels and concrete beams of 300mm thick and 0.50 m wide. These beams and corbels extend all around the internal perimeter of the dry dock.
